DEPARTMENT OF TRANSPORTATION

Office of Structural Materials

Contract #: 04-0120F4Cty: SF/ALA Rte: 80 PM: 13.2/13.9File #: 69.28**WELDING INSPECTION REPORT****Resident Engineer:**Pursell, Gary**Address:** 333 Burma Road**City:** Oakland, CA 94607**Report No:** WIR-004605**Date Inspected:** 14-Oct-2008**Project Name:** SAS Superstructure**OSM Arrival Time:** 700**Prime Contractor:** American Bridge/Fluor Enterprises, a JV**OSM Departure Time:** 1700**Contractor:** Zhenhua Port Machinery Company, Ltd (ZPMC), Changxing Island **Location:** Shanghai, China**CWI Name:** Sun Wei**CWI Present:** Yes No**Inspected CWI report:** Yes No N/A**Rod Oven in Use:** Yes No N/A**Electrode to specification:** Yes No N/A**Weld Procedures Followed:** Yes No N/A**Qualified Welders:** Yes No N/A**Verified Joint Fit-up:** Yes No N/A**Approved Drawings:** Yes No N/A**Approved WPS:** Yes No N/A**Delayed / Cancelled:** Yes No N/A**Bridge No:** 34-0006**Component:** Tower**Summary of Items Observed:**

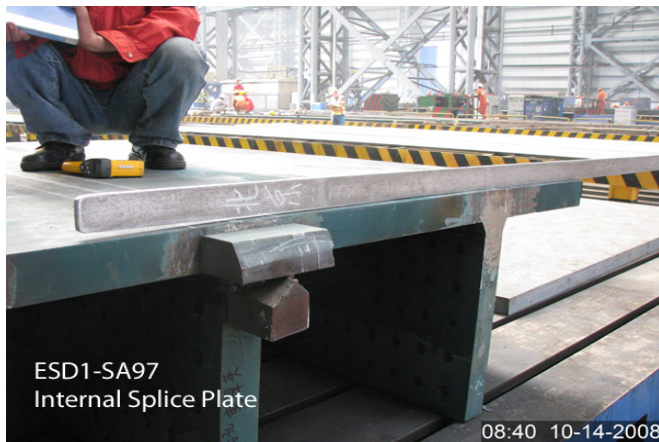
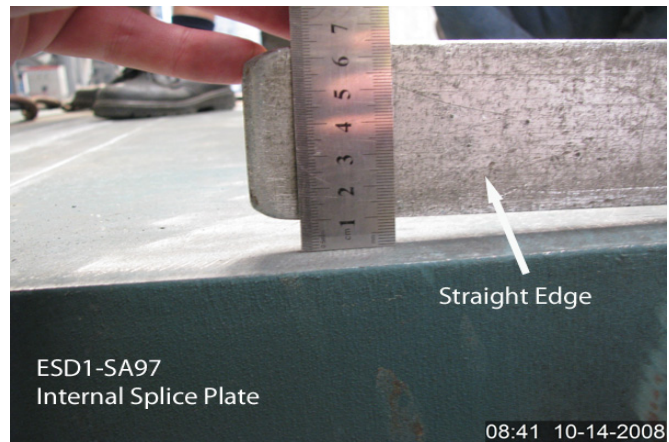
East Shaft Internal Bolted Splice Plate

The Quality Assurance Inspector observed ZPMC performing heat straightening operations to Internal Splice Plate ESD1-SA97 without prior approval from the Engineer. The Quality Assurance Inspector measured the member to be out of flatness by approximately 10 millimeters. ABF representative Mike Williams was informed that a Non Conformance Report would be generated pertaining to the requirements of ZPMC Welding Quality Control Plan Section 11.1.2 which states "For material greater than 16mm in thickness, heat straightening shall not be performed on members with out-of-flatness tolerances greater than 3/1000 without prior approval of the Engineer. Below are digital photographs illustrating the discrepancy.
